Friends Meeting House, Airton

Airton, Skipton, BD23 4AE

Statement of Significance

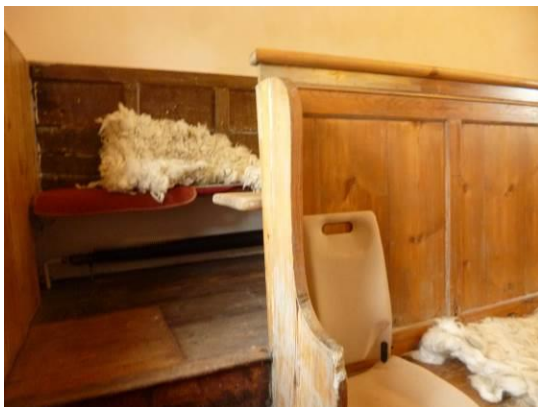
The meeting house interior is divided into two unequal spaces with the main meeting room to the south-west. The stand is against the south-west wall; this has oak panelling to the rear dado, end steps, a fixed pine bench to the front, and pine tongue and grooved dado to side walls, ramped to the stand; the pine joinery appears to be early nineteenth century in date, but the oak panelling is earlier. The smaller meeting room to the north-east is separated by a simple horizontally boarded oak screen with top-hung hinged shutters. Narrow stairs in the north-west corner lead to the gallery; the gallery floor is supported on a pair of chamfered posts and two chamfered beams with exposed joists and the gallery front is plainly panelled. The matching stone fireplaces on both floors, each have chamfered arrises and deep chamfered cornices. These fireplaces and the oak joinery are typical of the late seventeenth century. The ground floor fireplace has a nineteenth century cast-iron grate. Walls and the flat ceilings are plainly plastered with lime-wash finish. Floors are boarded in pine. The 3-bay roof has two tie-beam trusses with struts; one has curved principals.

Fig.2: stand with fixed benches of varying dates

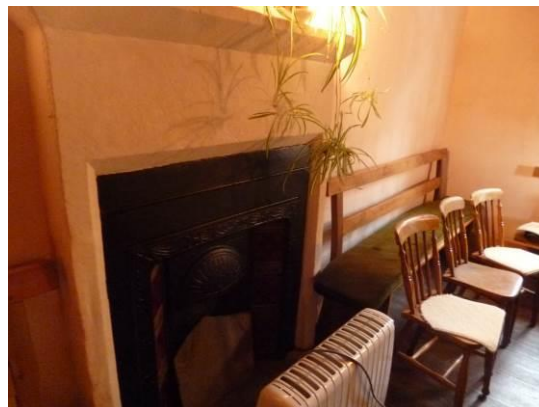
Fig.3: one of two stone fireplaces in the smaller rooms to the east end

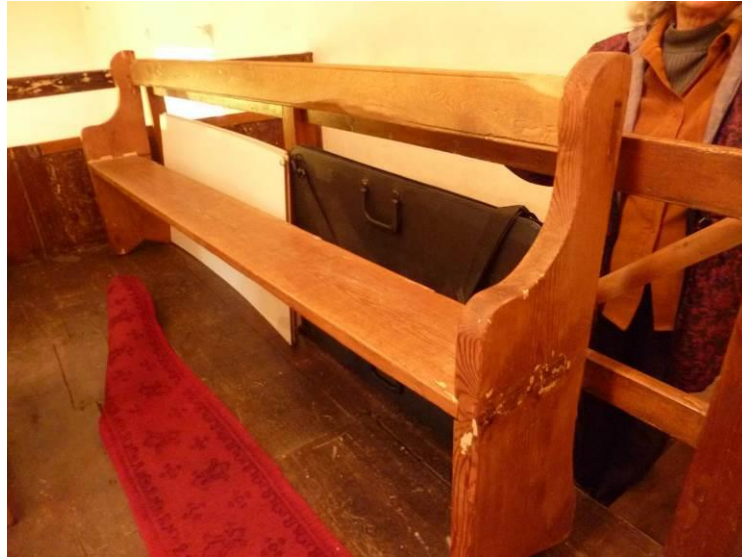
The meeting house contains a collection of pine benches of varying design, including several with reversible backs. One of the benches with solid ends on the gallery has the date 1826 on the back of the rail, perhaps re-used from another bench.

Fig.4: pine bench on gallery with back rail inscribed JB 1826

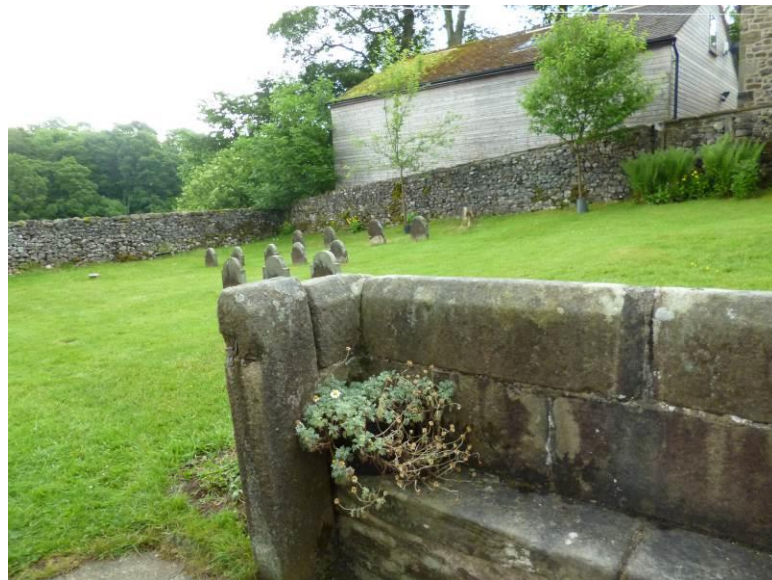
Fig.5: burial ground and stone bench set in wall, from the west

The sloping burial ground adjoins the meeting house on its south and east sides, enclosed by drystone walls. The roughly L-plan area is laid to grass with rows of head stones towards the east end; the stones have arched tops in the usual Quaker style, dating from the second half of the nineteenth century. A low ashlar wall separates the paved yard on the south-east front of the meeting house from the burial ground; the wall has an integrated stone bench to the side facing the meeting house and the top of the wall is chamfered. This unusual feature is hard to date; it is said to be seventeenth century in date, but may be later. A gateway with flat
